**Interpretation of Electrical Test Data with Regards  
To Microwave Cable Assemblies**

Prepared By:  
Dave Slack

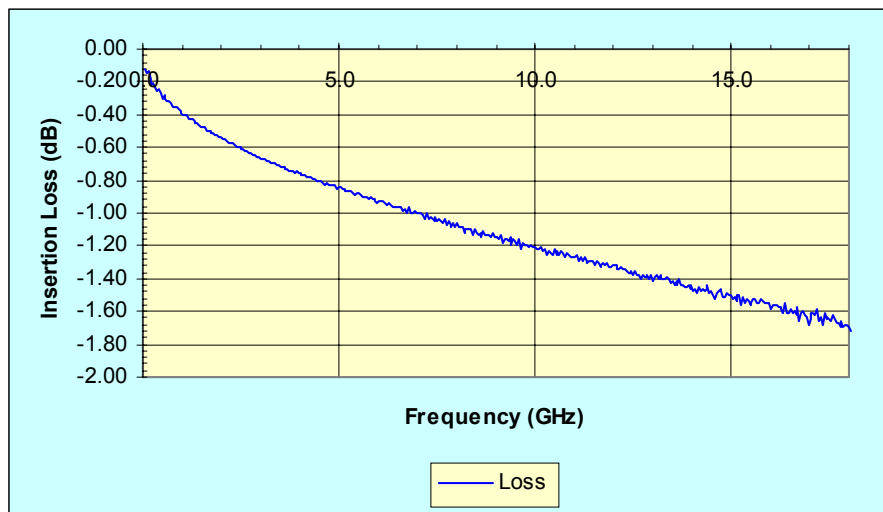
Figure 1 depicts a typical insertion loss vs. frequency plot of a coaxial cable assembly.

Note that the fine grain ripple on the graph becomes more pronounced as frequency increases. This is due to the mismatch loss that is a result of less than perfect impedance matching and will be discussed later.

Total insertion loss is the sum of connector loss, cable loss and mismatch loss.

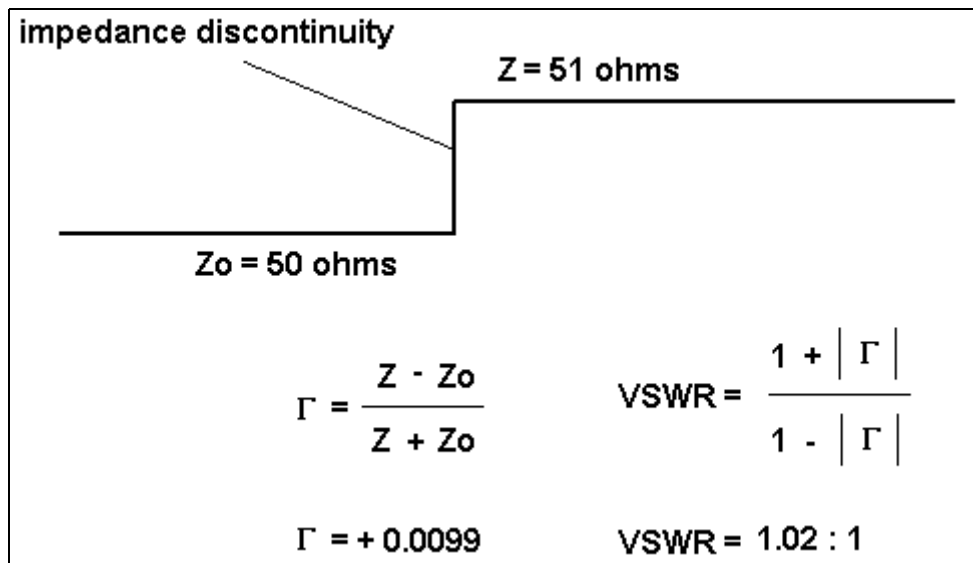
Figure 2 illustrates a very simple case of a perfect system containing one, very simple discontinuity. A realistic system is composed of a virtually infinite number of cascaded discontinuities.

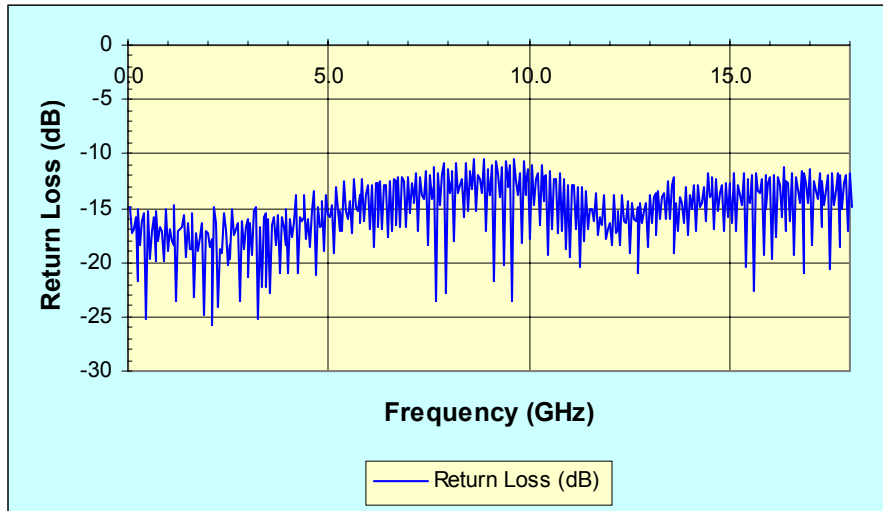
Figure 5

The return loss vs. frequency graph of the above assembly is shown in figure 5.

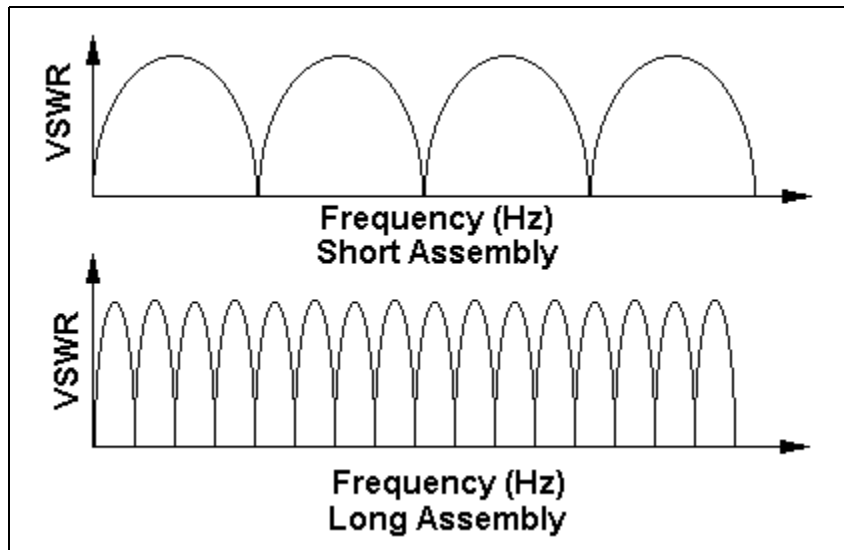
Figure 6.

When cable assemblies are longer the propagation delay is longer. This causes the frequency differential between the peaks and nulls to become smaller. For a short assembly the VSWR vs. Frequency plot has a long period to it and represents a rectified sine pattern. As the assembly becomes longer the VSWR pattern takes on a fine grain “ripple” effect.

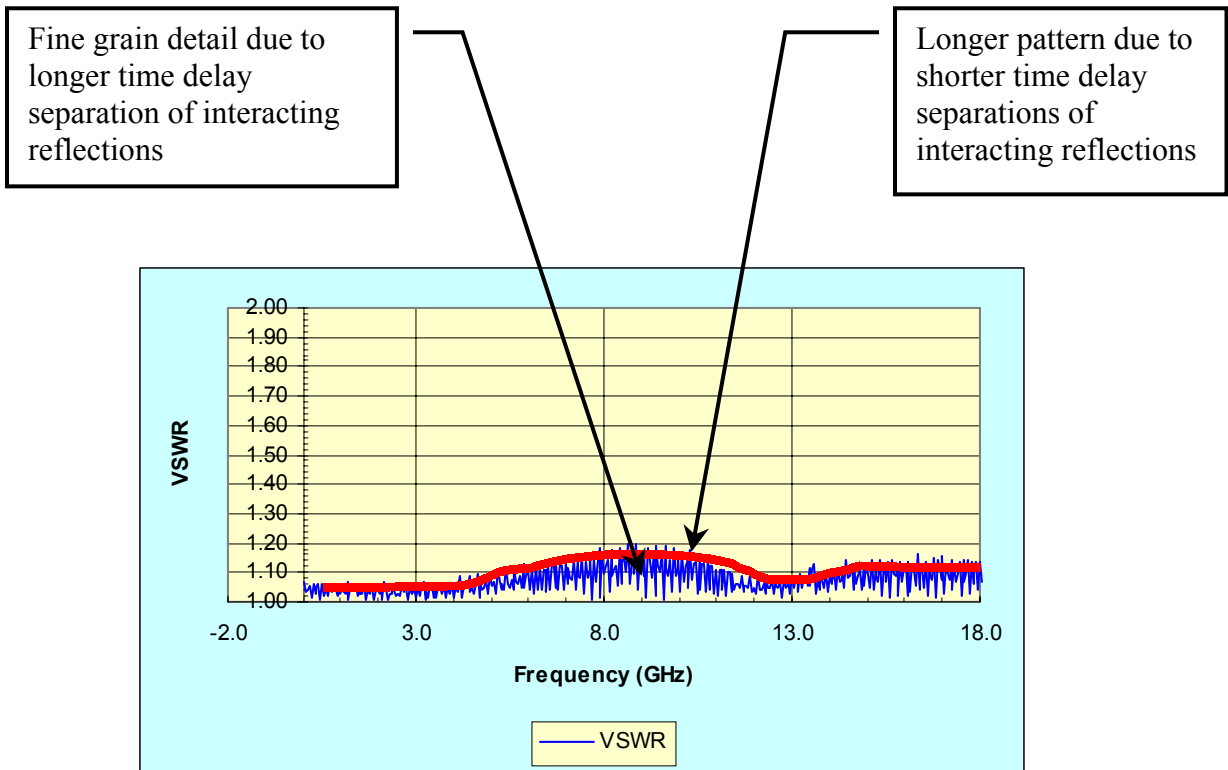
Figure 7

As the cable assembly deviates from this simple model towards a more practical model the VSWR pattern becomes more complex. The individual parts of a connector will interact with each other. The time delay between these parts is small. This causes a fine grain VSWR to be superimposed on a long flowing pattern.

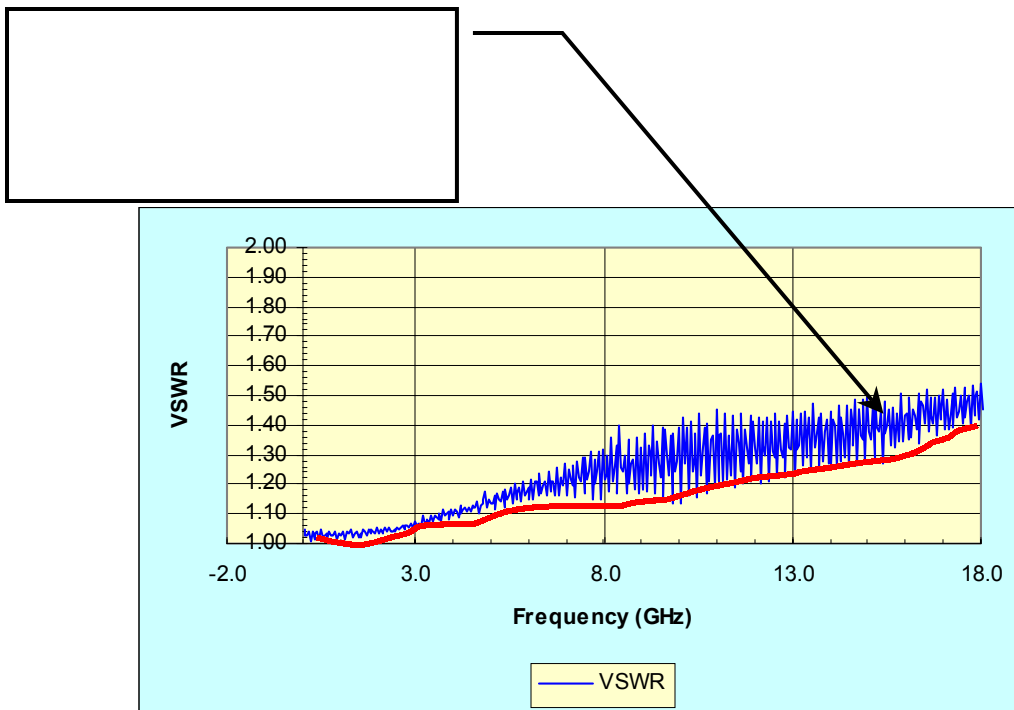
Figure 8

When the VSWR nulls significantly deviate from 1.0:1 VSWR it is indicative of a problem with one of the connectors. It is letting us know that the reflection coefficient magnitudes of the two connectors are no longer close to being equal.

This can be caused by high resistance contact points within the connector, poor solder quality, or a high reactive impedance mismatch caused by an incorrect dielectric.

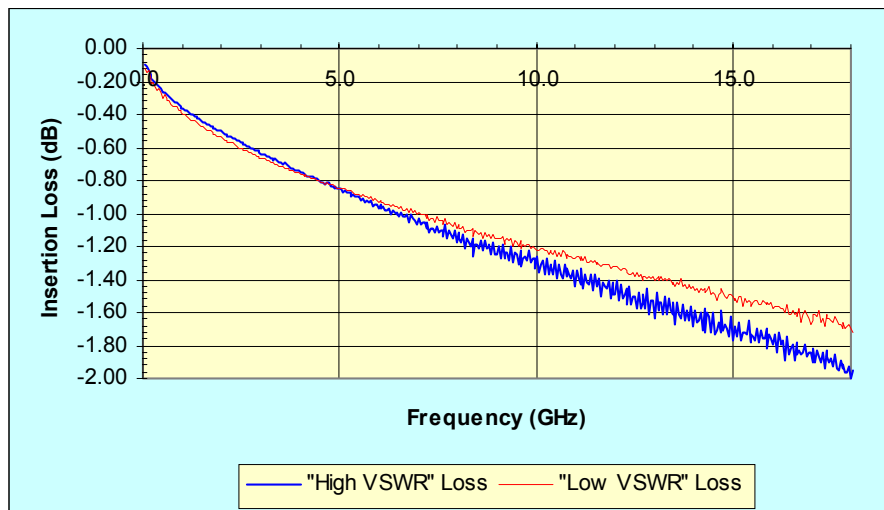
Figure 9 illustrates two separate assemblies. One having a high VSWR and the other having a normal VSWR.

The high VSWR assembly is slightly longer in length (and higher in loss) such that their respective curves do not overlay each other. From the quality of the curves the effect of the high VSWR on insertion loss is readily apparent.

The fine grain ripple due to mismatch loss that is superimposed on the attenuation curve is much greater on the high VSWR assembly.

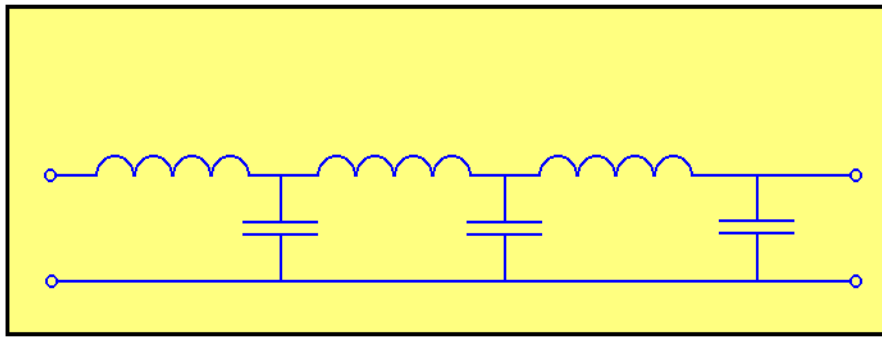
Figure 10

The lumped constant model of a coaxial transmission line is that of a multi pole, low pass filter as shown in figure 10.

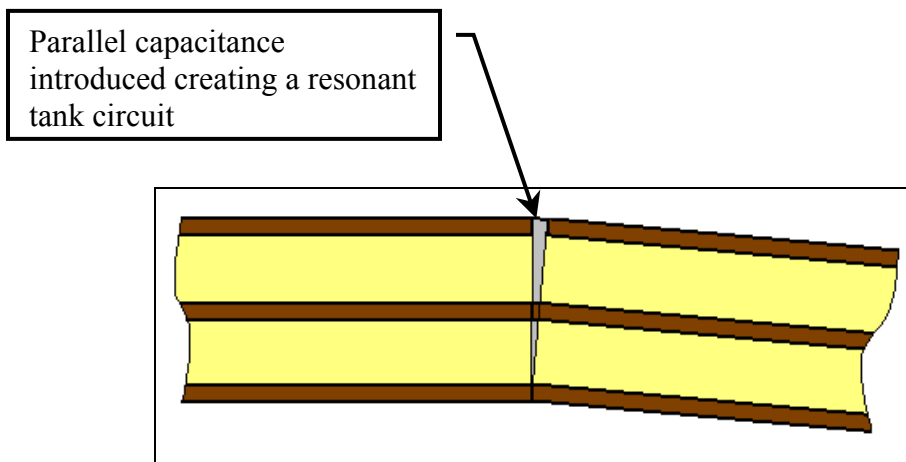
Figure 11

For a coaxial system to work properly all of the mechanical mating parts must have complete contact, throughout 360 degrees of circumference of the inner and outer conductors. When parts are not correctly assembled, or not mated with sufficient contact pressure, this 360-degree contact is not maintained and a resonance can result.

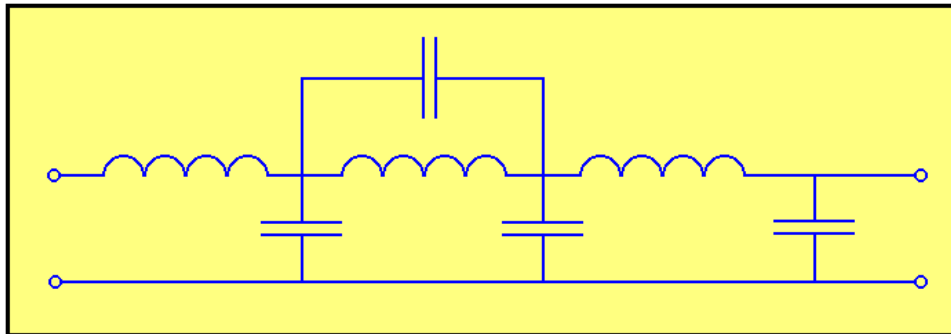
Figure 12

The resultant lumped constant model is illustrated in Figure 12. A parallel LC tank, at resonance, presents very high impedance. This causes the transmission line model to have a band stop characteristic that is not desirable in most applications.

The center frequency and bandwidth of the band stop characteristic is a function of the degree of separation severity of the mis-matched parts.

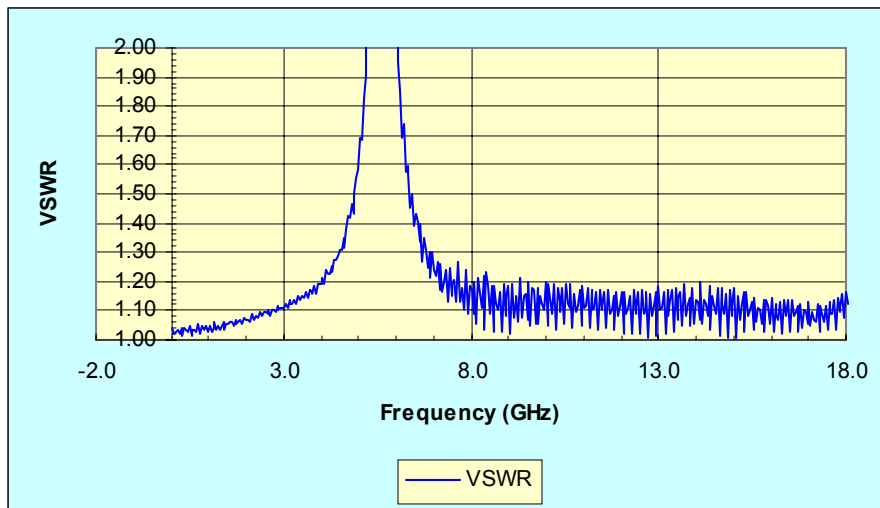
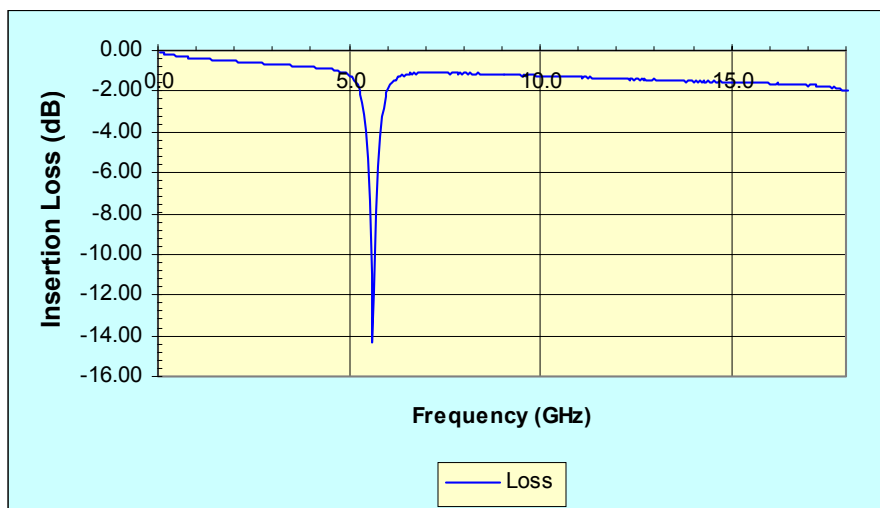
The effect on insertion loss and VSWR are illustrated in figures 13 and 14.

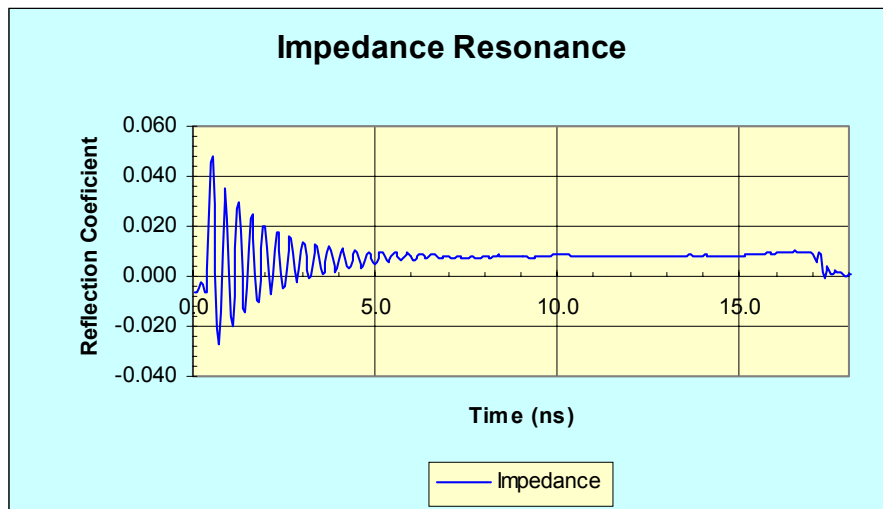
Figure 15

The effect can be further noted when viewing impedance vs. time (distance) plot of an assembly having mismatched or loose parts. Fig 15. It is evident upon inspection of the plot that the input connector displays significant “ringing” that is typical of a resonant condition.

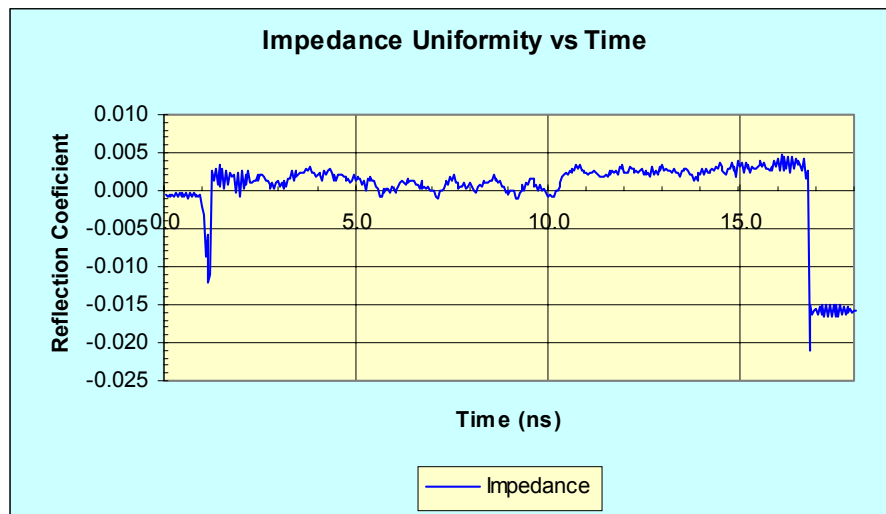
Figure 16

There are cases where, for a variety of reasons, the cable impedance uniformity is less than perfect. This is illustrated in figure 16.

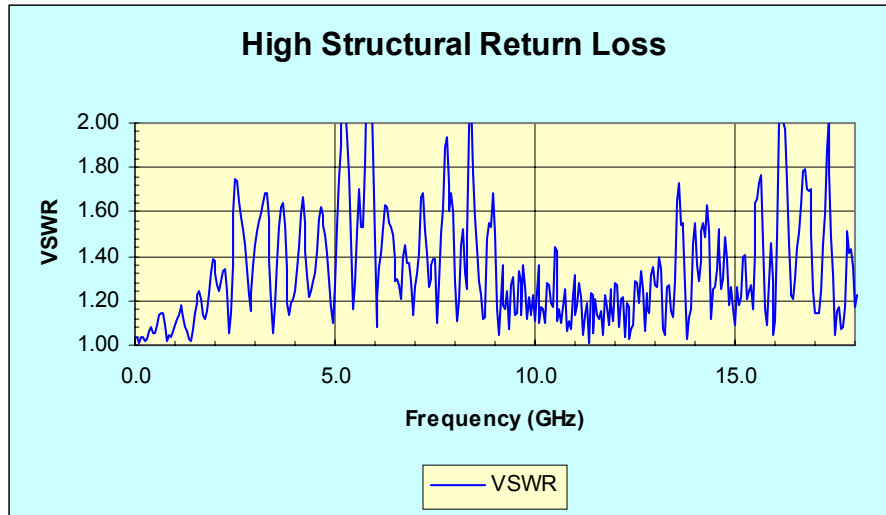
Figure 17

These sorts of “structural” discontinuities yield a non-uniform, non-repetitive VSWR pattern. This type of pattern is typically referred to a high structural return loss as illustrated below.

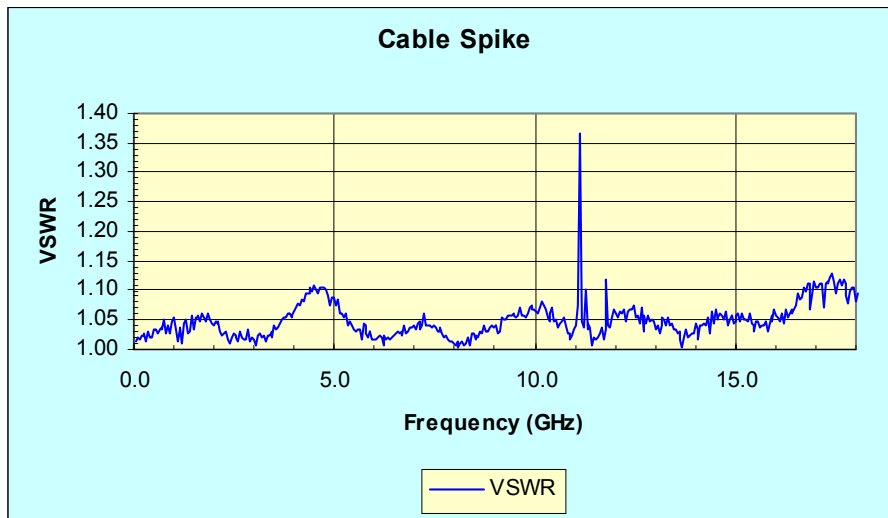
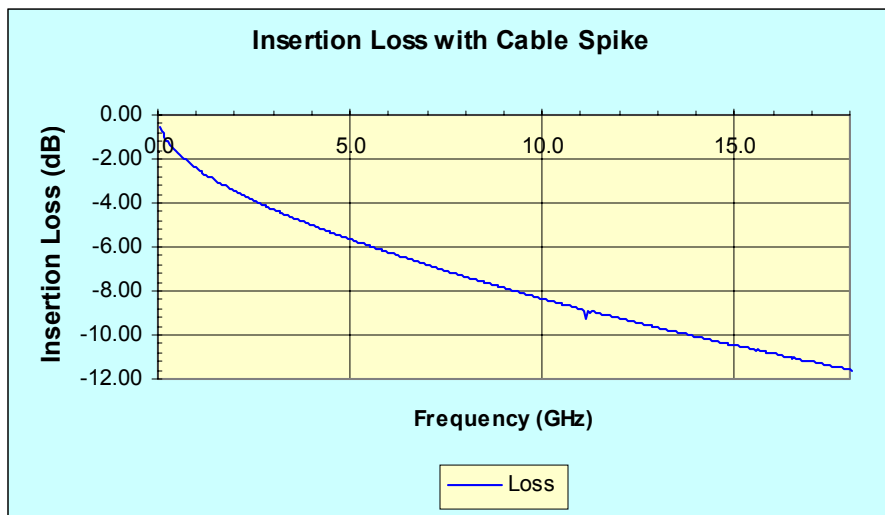
This phenomena is commonly known as a “cable spike”. The larger the discontinuities, the more consistent the spacing, and the longer the amount of cable affected the larger the cable spike can become.

Figure 20 illustrates the impedance plot of the cable spike assembly. Figure 21 is a close up showing the fine impedance discontinuities and their repetitive nature. A period of 90 pico seconds causes the 11.1 GHz spike noted in Figure 18.

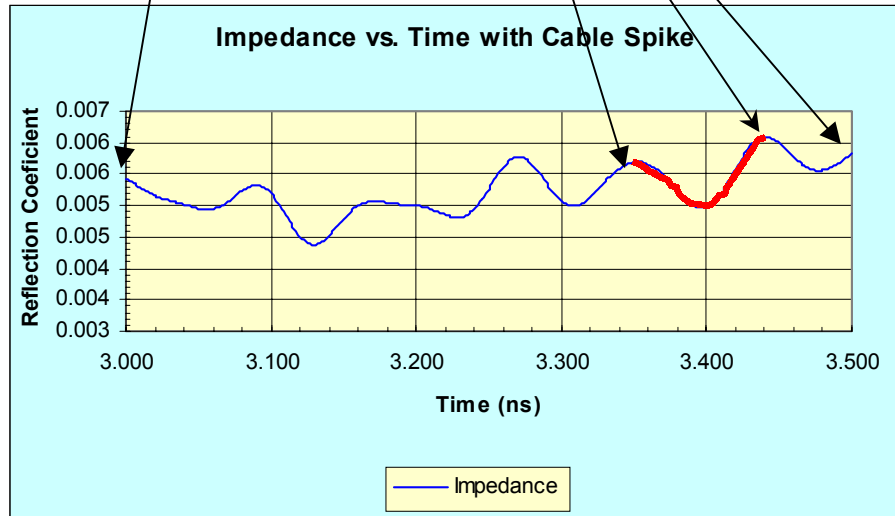
Figure 21

Time between  
peaks is 90 ps

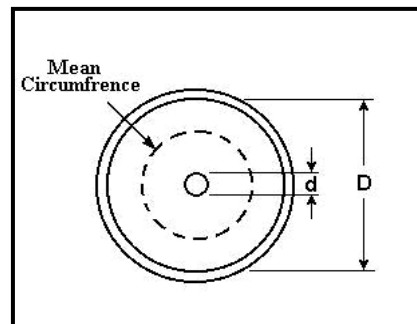
The maximum operating frequency, that is free of TE or TM modes, is referred to as the frequency of cutoff ( $f_c$ ). This is illustrated below.

$$f_c = \frac{2cV_g}{\pi(d+D)}$$

- C = velocity of light (in/sec)**
- Vg = Velocity of propagation (% C)**
- D = ID of the outer conductor (inches)**
- d = OD of the inner conductor (inches)**

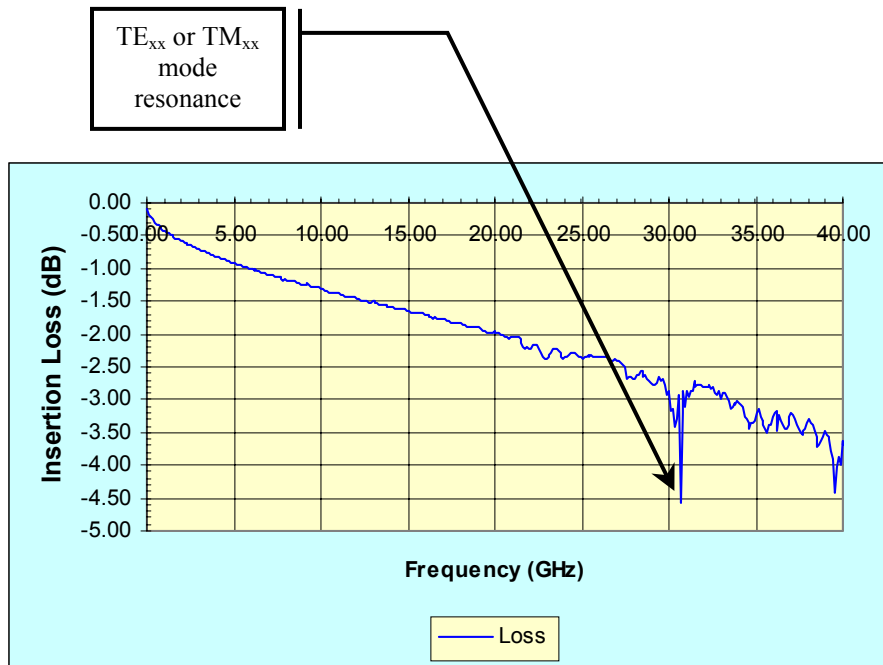
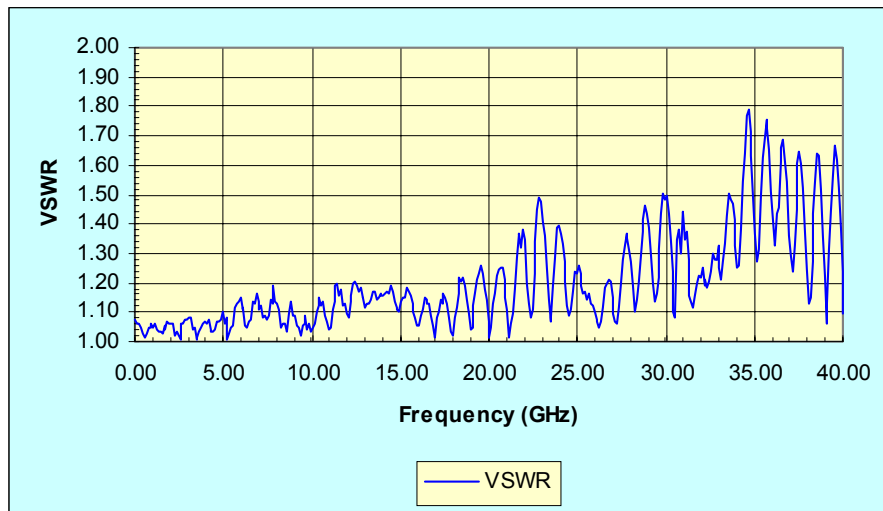
A VSWR and insertion loss plot of a cable assembly operating beyond its cutoff frequency is shown in figure 19 and 20.

Figures 24 and 25 are a 3 GHz section of figures 22 and 23. These serve to illustrate that, unlike a cable spike, the effects of operation beyond cutoff are not always evident in the VSWR plot.

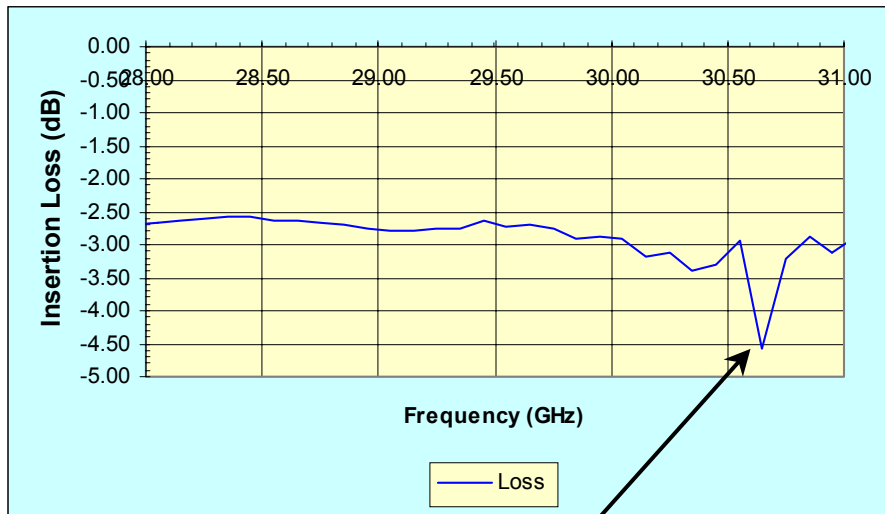
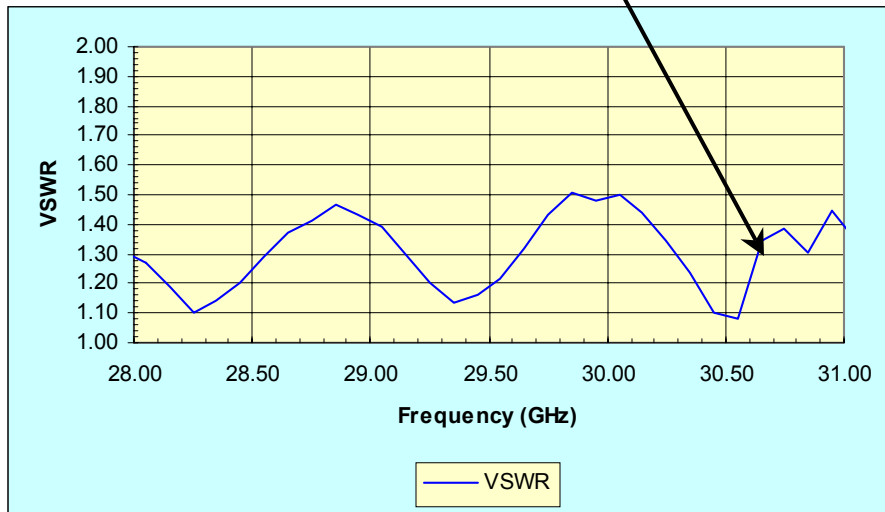
Not always  
noticeable  
in VSWR

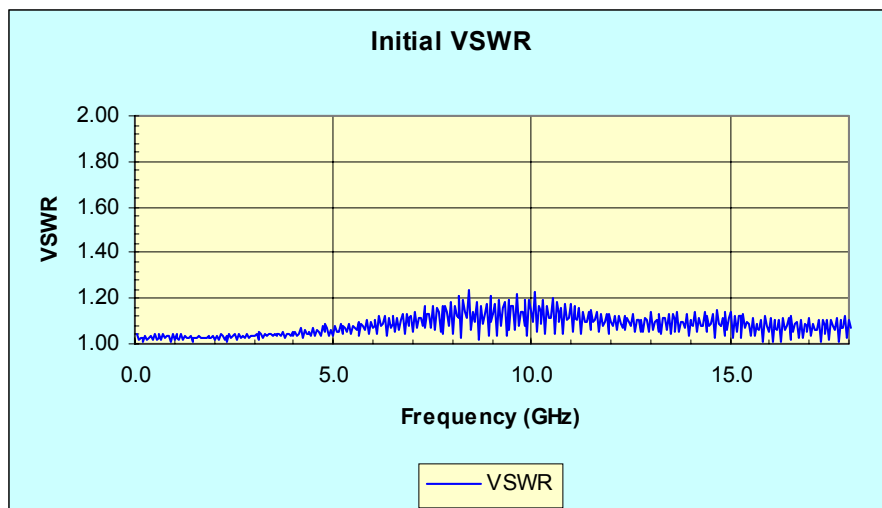
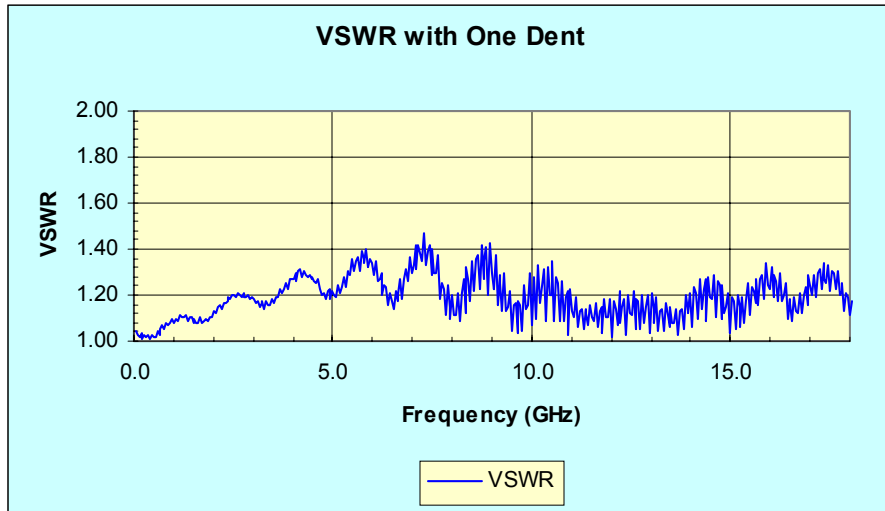
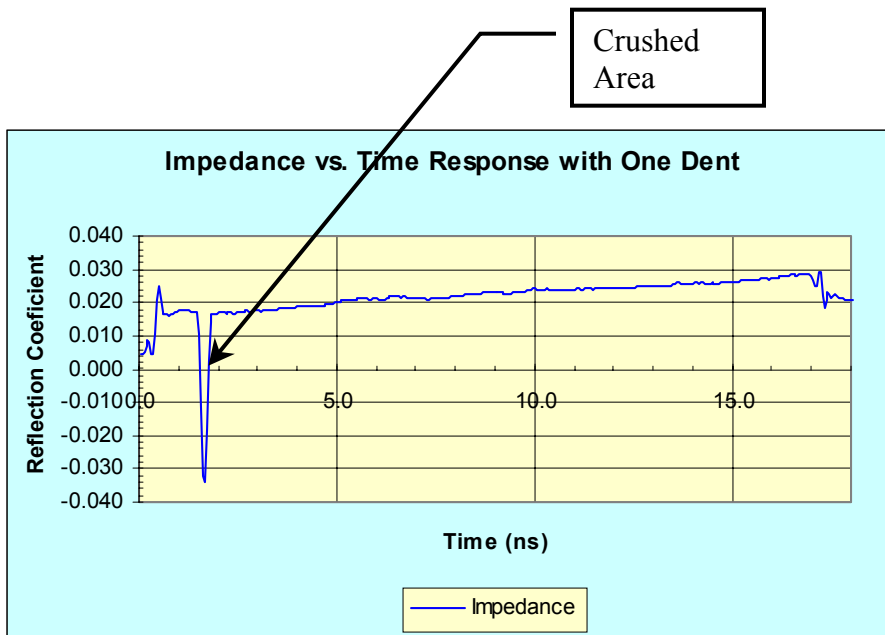
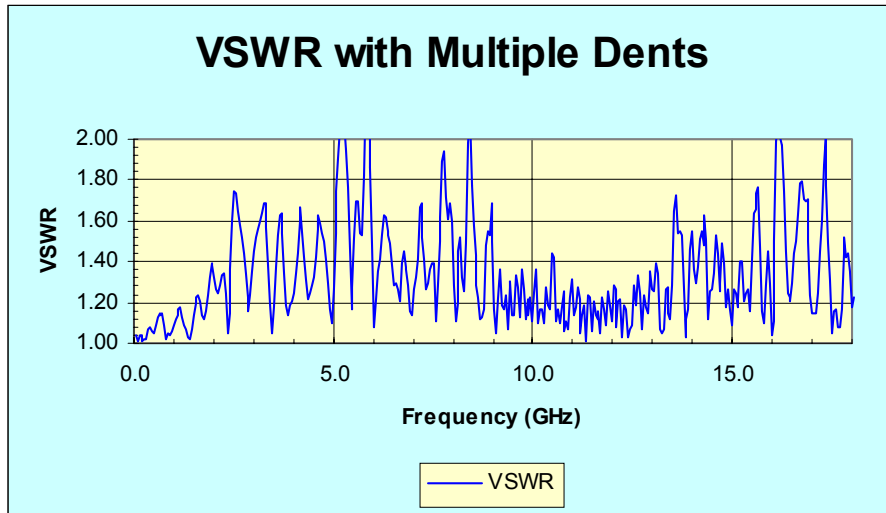
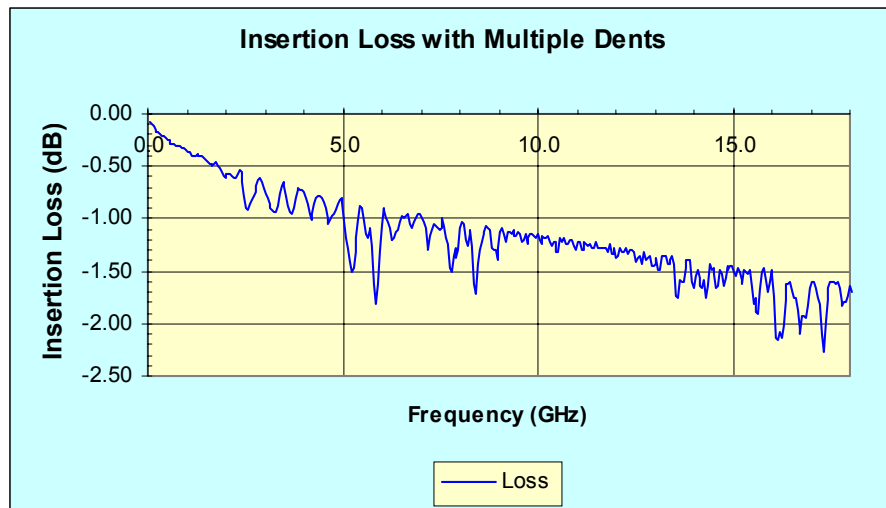
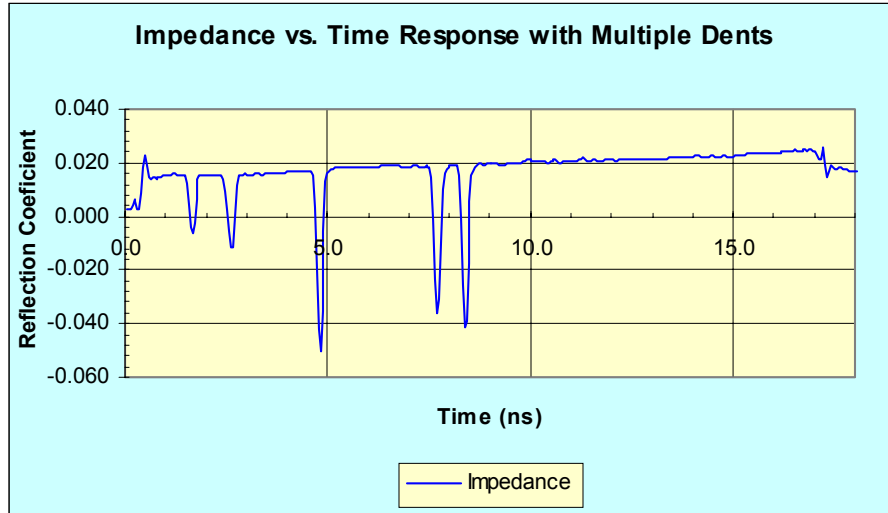
When the cable is crushed or dented the outer diameter ( $D$ ) is reduced and the  $V_g$  is also reduced. This lowers the impedance and causes an impedance discontinuity.

The following series of figures illustrates the effects on impedance and VSWR when a good assembly has dents imparted into it.

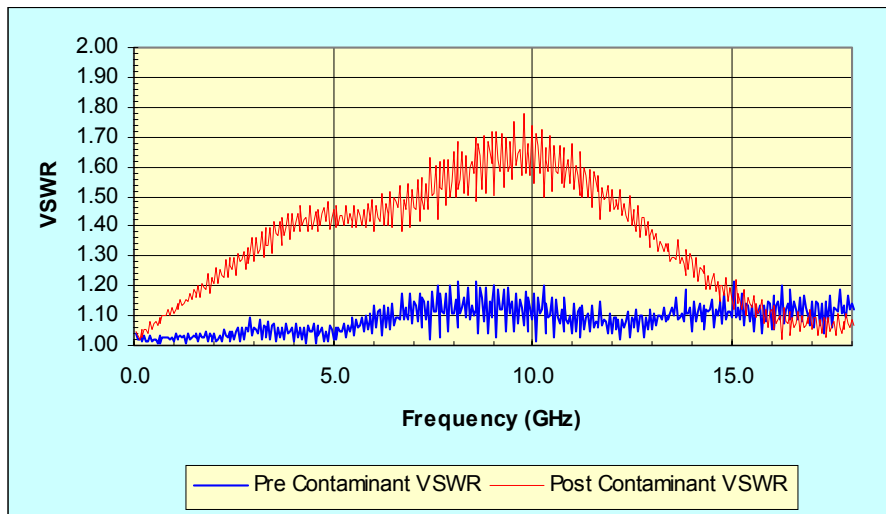
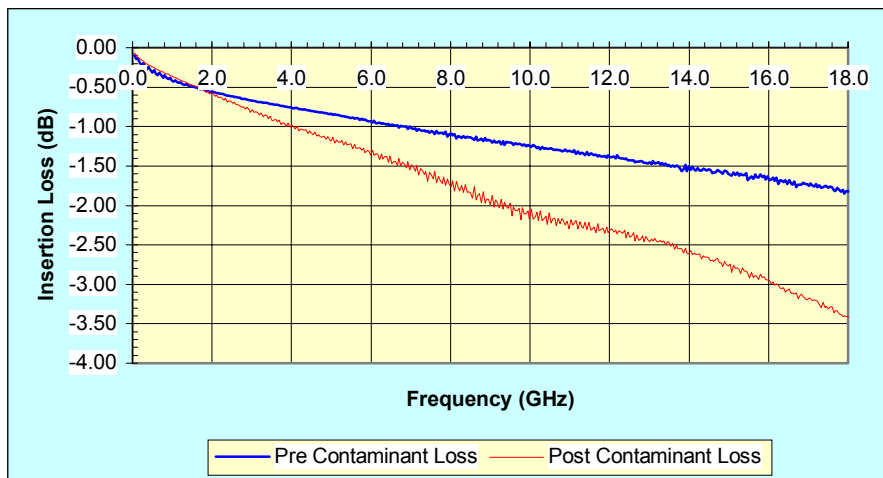
This failure manifests itself in the form of lower impedance where, the core is contaminated, as well as an increase in insertion loss by more than the increased mismatch loss would normally indicate.

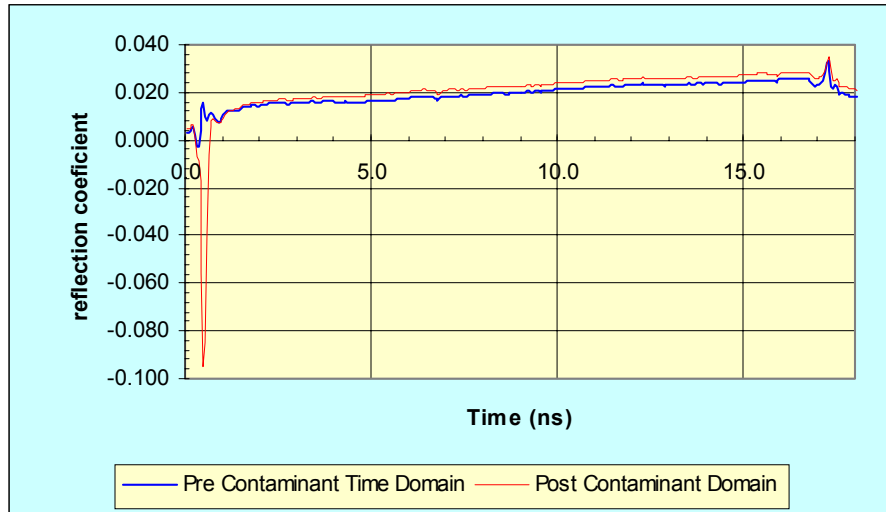
Figure 34

If the contamination ingress is due to solvents used in the installation of the connector the impedance discontinuity will be evident at the beginning of the cable assembly as shown in figure 34.
